| <b>Building Number:</b> | <b>630</b> | |

### Task One: Conditions Assessment

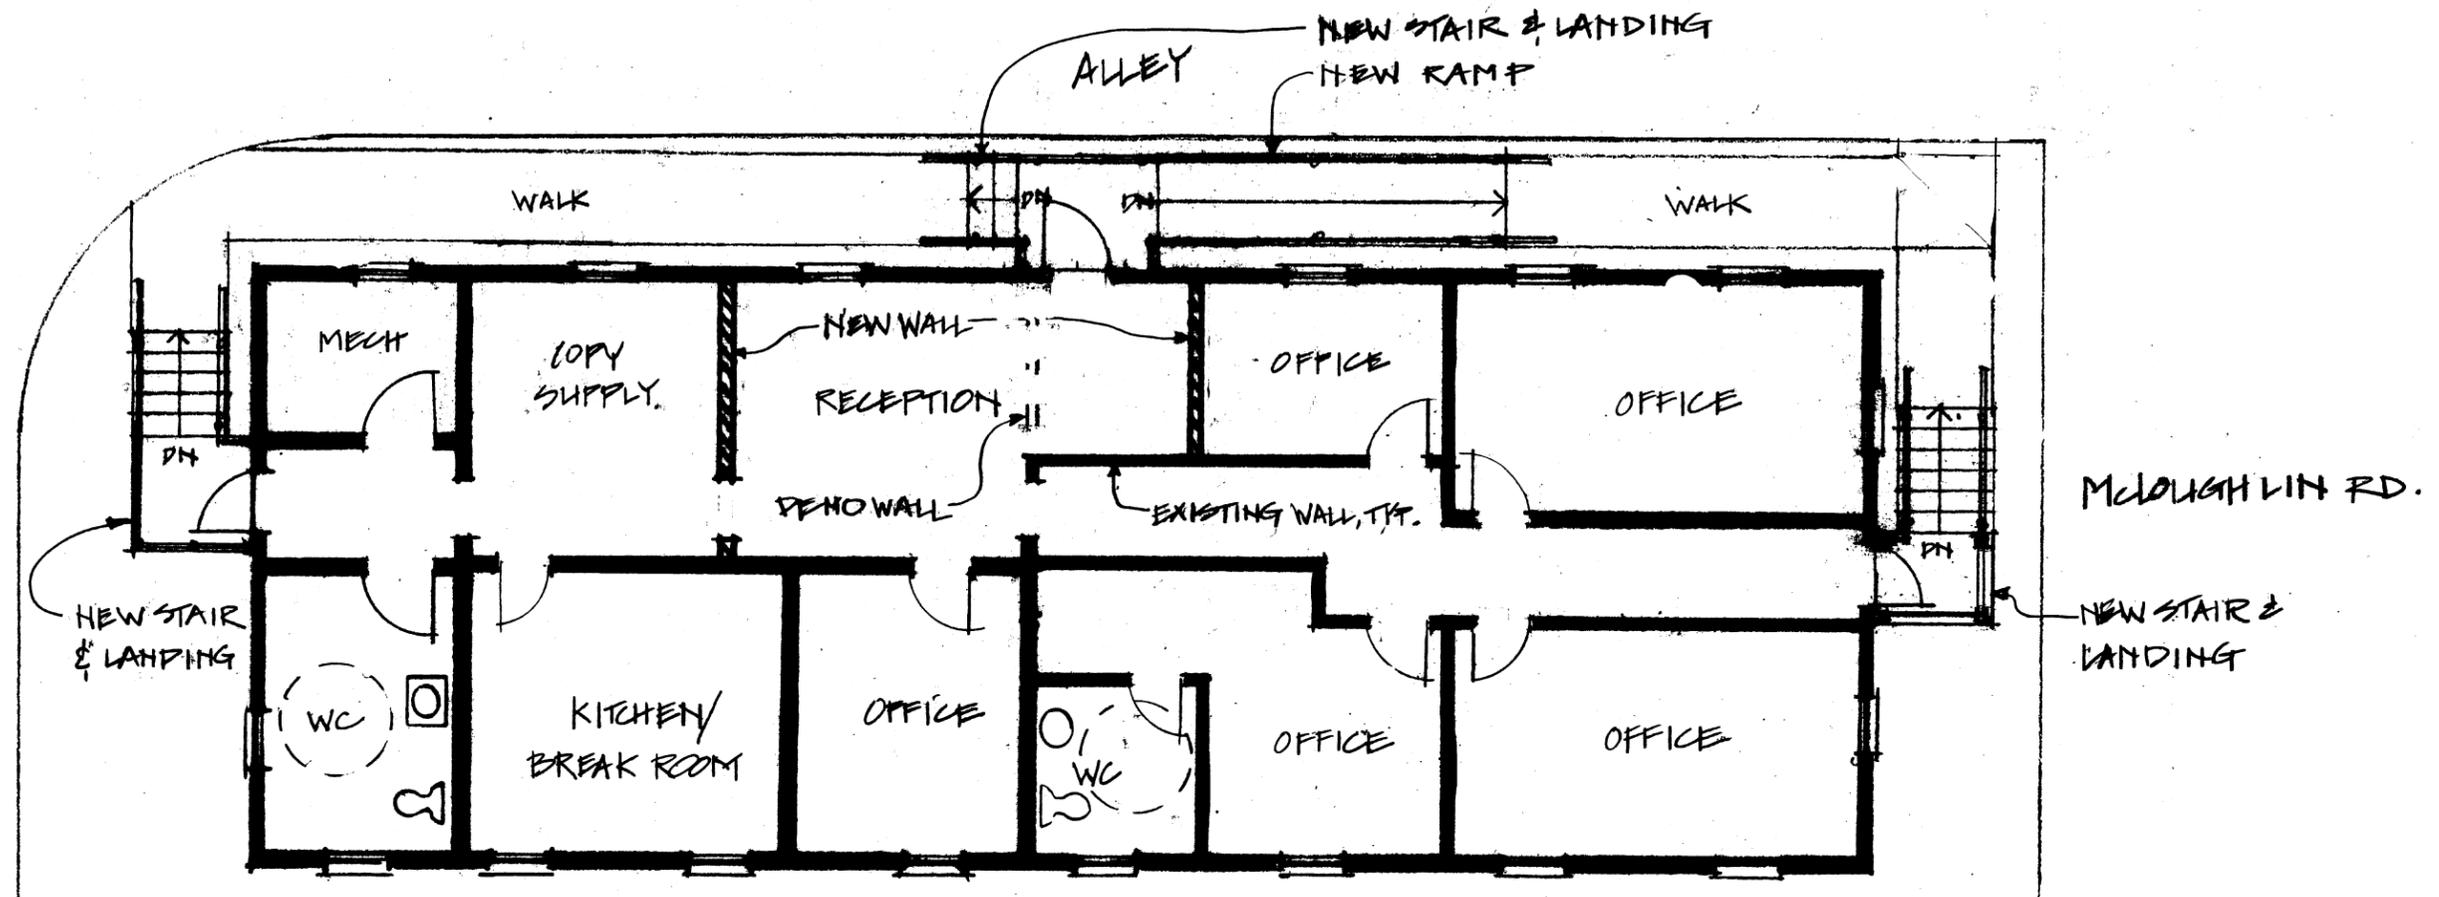
BUILDING 630-OFFICE  
 SCALE: 1/8" = 1'-0" ↑

The Class 'C' cost estimate for an office use for the year 2003 is \$78.08. This cost assumes that the interior wall configuration would remain and that the majority of the cost would be applied to code upgrade and finishes.
